Progressive Collapse – Historical Perspective

Brian Crowder, P.E.

3/21/2005

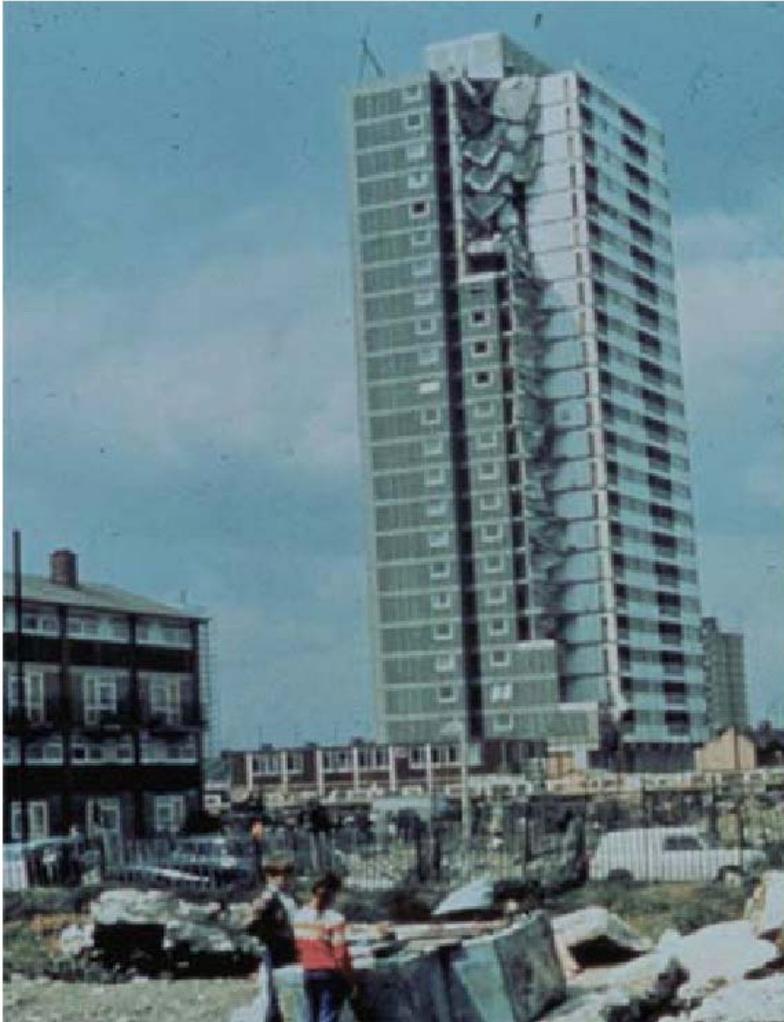
Ronan Point Apartments

- **Watershed event for progressive collapse**
- **22 story precast panel construction supported by cast in place concrete structure including parking garage**
- **Gas explosion occurred in 18th story apartment**
- **Wall panel blew out, causing loss of support of panels on 19-22nd flrs**
- **Debris of upper floors caused each floor below to successively collapse**

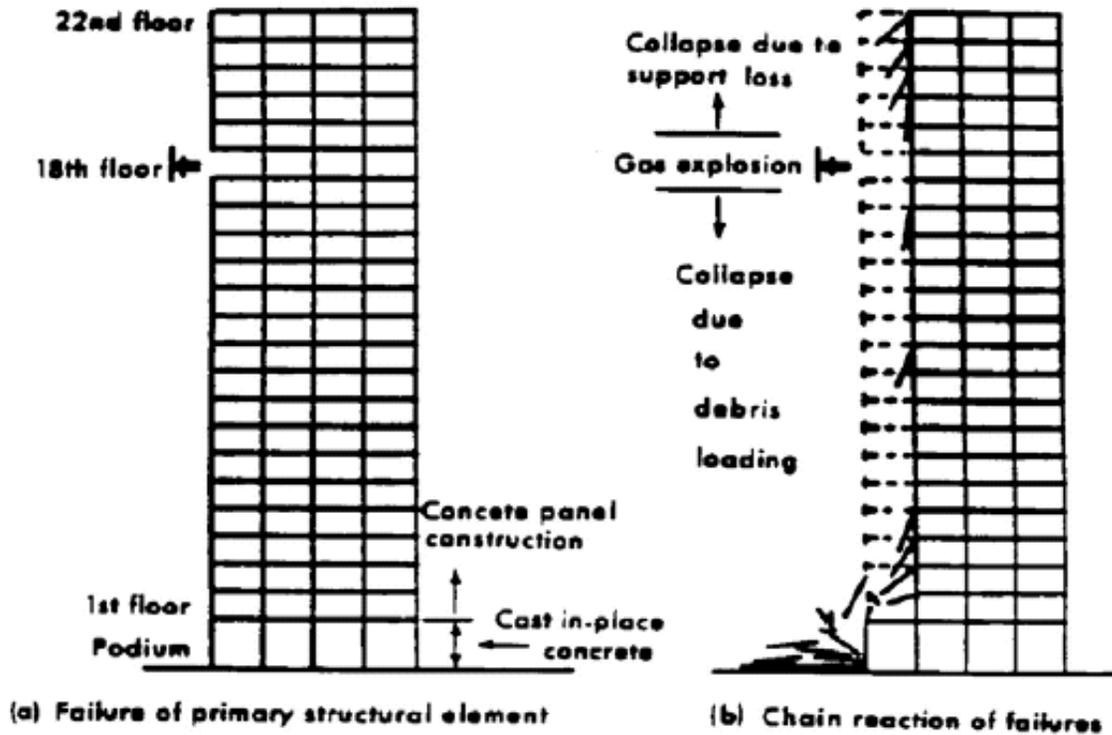
Schematic of the Ronan Point Collapse, Modified After Dragosavic (15).

- Found no violation of any applicable building standard, nor defect in workmanship
 - Building standards gave detailed requirements for design of elements, but little guidance on stability of entire structural system
 - Joint forces resisted solely by bond, friction, and gravity
 - Upon removal of the walls, connection above could not redistribute loads since they were designed only for compression
- There were some existing building standards and codes of practice that contained general warnings and guidance on design of large panel structures that may have mitigated some of the problems at Ronan Point

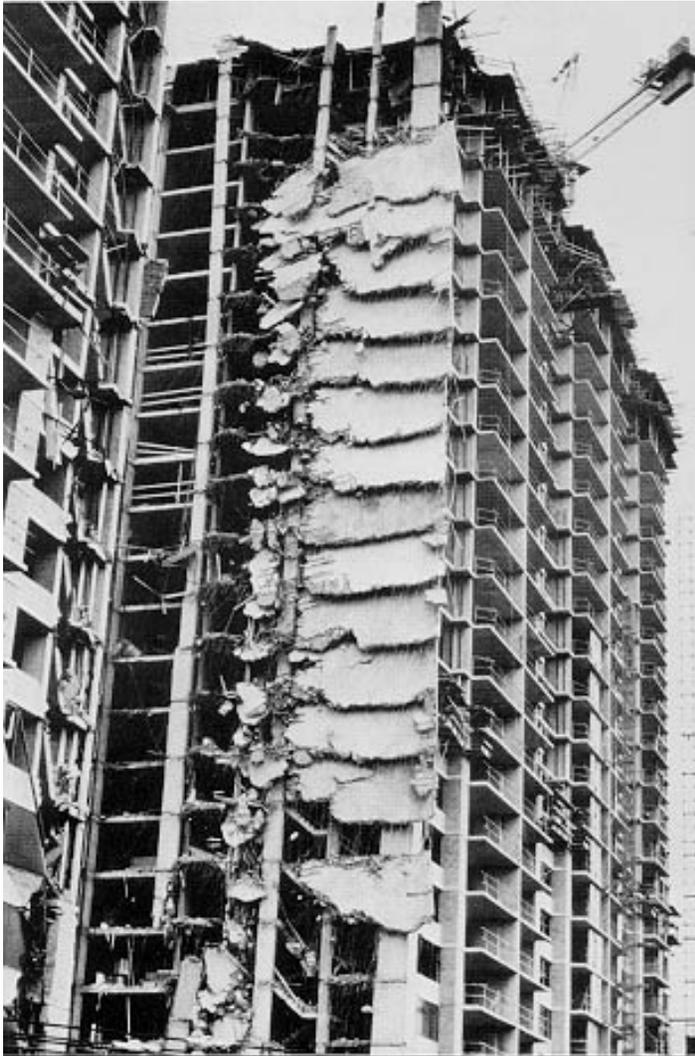
Skyline Plaza

- **March 2, 1973**
- **While concrete was being placed on the 24th floor and shoring removal was occurring on the 22nd floor a collapse occurred for the full height of the tower**
- **Impact of debris also caused horizontal progressive collapse of entire parking garage under construction adjacent to the tower**
- **14 workers killed, 34 injured**

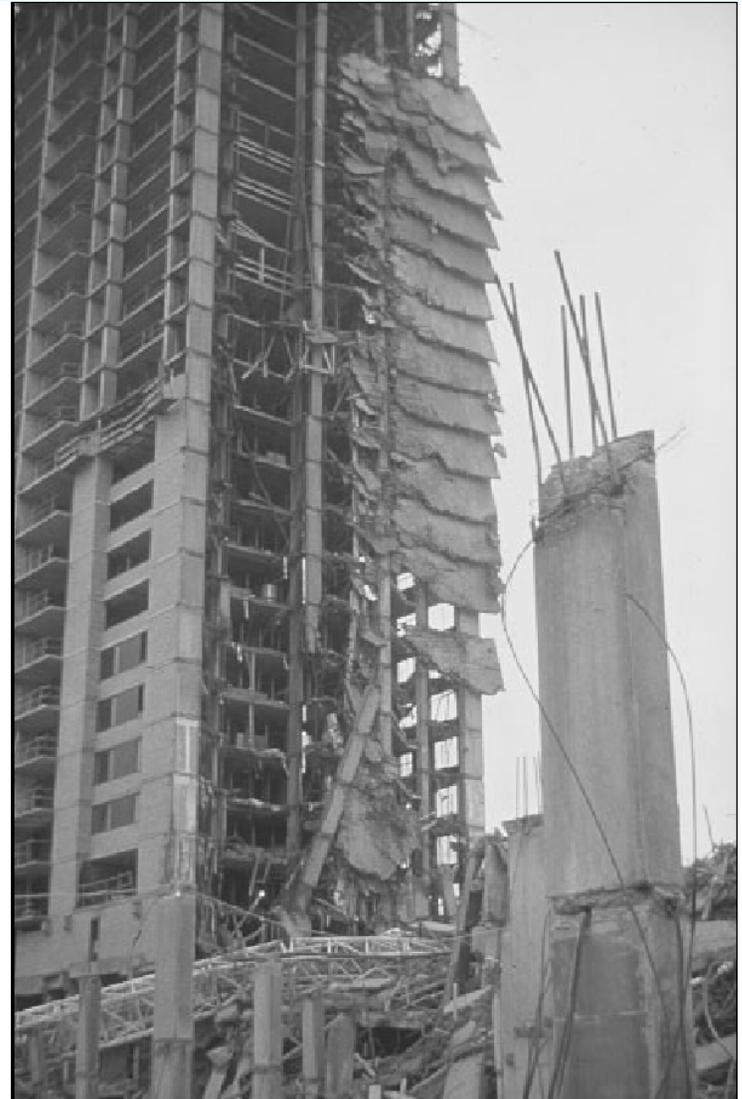
Skyline Plaza

- Tower was reinforced concrete flat plate construction
- Study of failure indicated premature removal of 22nd floor slab shoring lead to punching shear failure of the slab around one or more columns at the 23rd floor
- The weight of debris caused the failure of all the lower floors for the full height

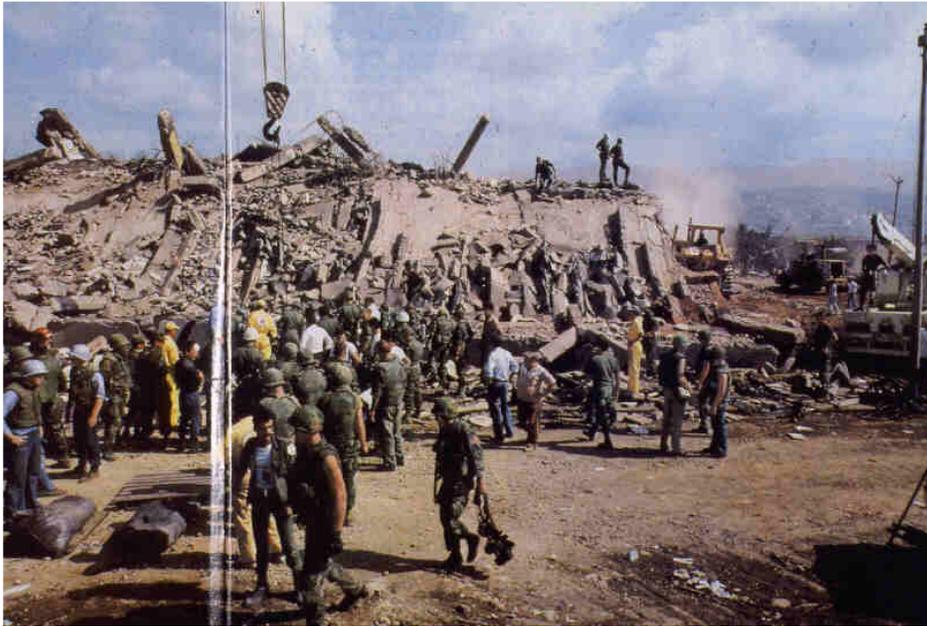
Marine Barracks, Lebanon

- One of the first large scale terrorist attacks on DoD facilities causing significant collapse and casualties
- Estimated bomb equivalent weight of 12,000 lbs. TNT
- 241 U.S. personnel killed, 80 wounded
- Although no direct changes were made to U.S. national building codes or DoD design criteria, the event began a history of attacks that eventually influenced design to prevent progressive collapse

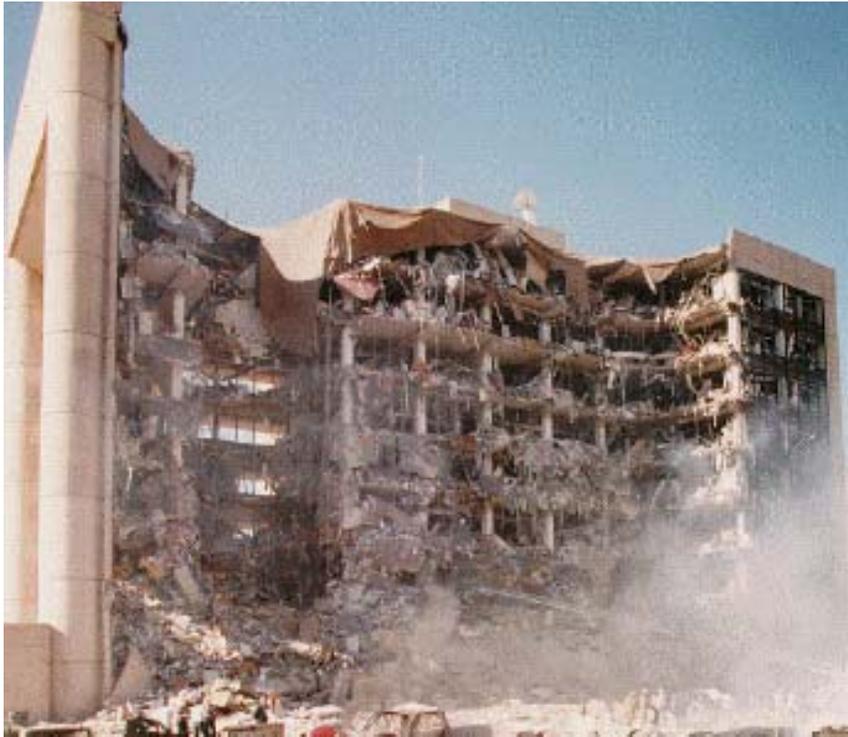
Murrah Federal Building, Oklahoma City

- April 19, 1995
- Explosive charge equivalent to approximately 4000 lb. TNT detonated on north side of building
- Building was designed in early 1970s
- Nine story, reinforced concrete OMRF, one way slab system
- Transfer girder at third floor level supporting intermediate columns, providing 40' clear span for first two levels

- **Analysis based on the approximated blast loading indicates that the column nearest the explosion (G20) would have failed by brisance or shattering**
- **The columns on either side of this column (G16 and G24) were found to have exceeded their shear strength and failed in shear. The loss of these three columns resulted in the transfer girder being unsupported for a distance of approximately 160 ft.**
- **The transfer girder then failed, and the resulting progressive collapse of all of the floors above extended through most of the north half of the footprint and 35 feet into the building.**
- **Roughly half of the occupiable space of the Murrah building collapsed**

- **Whether this facility experienced progressive collapse is often debated based on whether initial damage was “local” or global in nature**
- **Most agree that changes in design to eliminate transfer girder, add continuity, and add ductility would have diminished extent of damage**
- **This event precipitated the adoption of security criteria by the General Services Administration which included design requirements to prevent or reduce the likelihood of progressive collapse (Nov. 2000)**
- **Event also influenced decision of DoD to incorporate progressive collapse prevention into AT criteria**

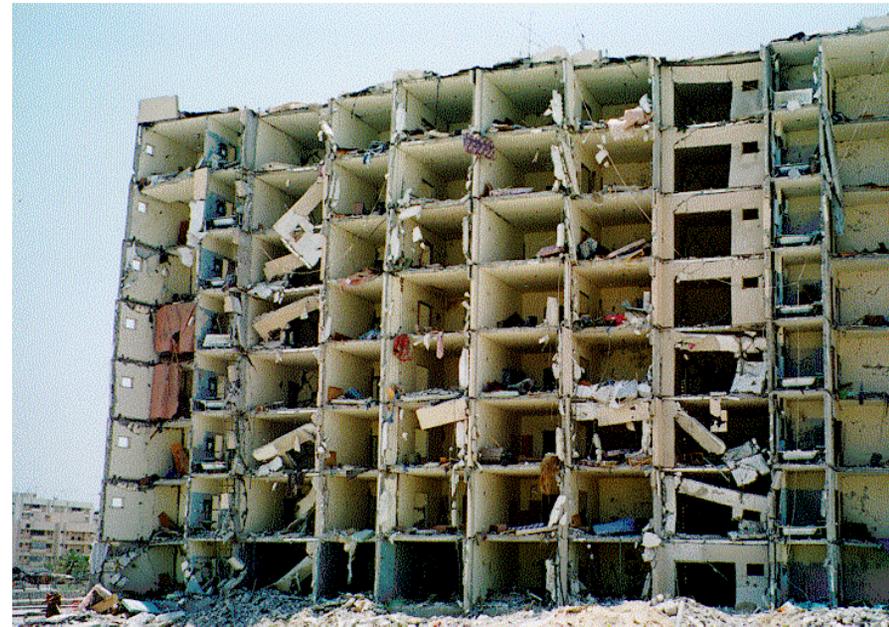
Khobar Towers

- **June 25, 1996**
- **Terrorist bombing of barracks facility – estimated equivalent weight of 20,000 lb TNT**
- **19 fatalities, 500 wounded**
- **Many believe structure is example of preventing progressive collapse**
- **“Downing report” following attack lead to development of specific force protection measures for DoD, including the DoD minimum AT standards for buildings**

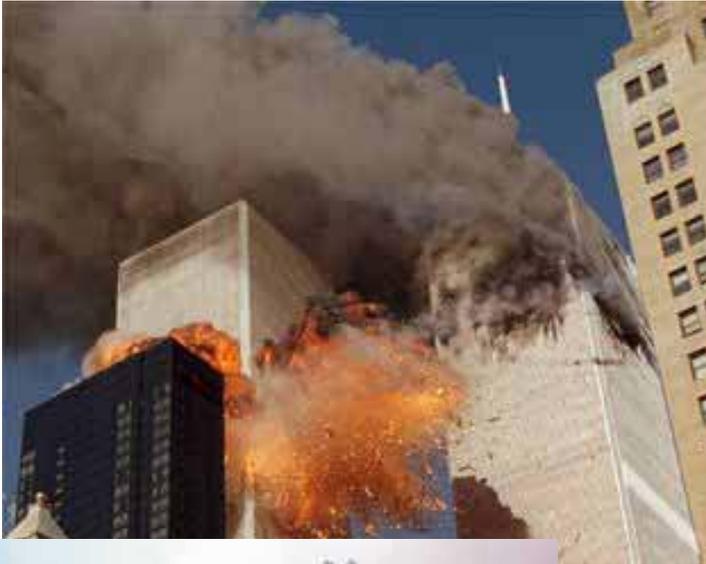
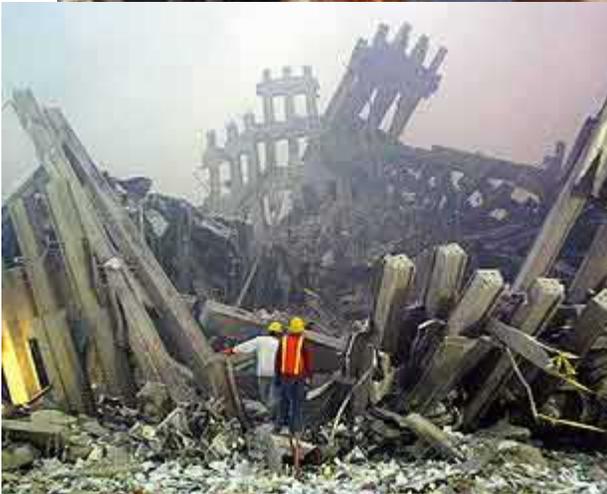
World Trade Center, 2001

- **September 11, 2001**
- **Two aircraft were crashed into the two World Trade Center Towers**
- **This single event lead to the greatest public exposure of the potential for inherent weakness in structures when exposed to unexpected or extreme loading**
- **10 major buildings experienced partial or total collapse**

- **The events of September 11, 2001 served to focus the engineering community once again on the issue of progressive collapse**
- **Ironically, the events on that day show progressive collapse averted in many cases. The towers themselves were able to withstand the initial loading from the impact of the airplanes, only to succumb at a later time due to the additional loading/weaknesses created due to the fire-structure interaction**
- **In addition, several buildings surrounding the towers received extraordinary damage from debris loading, but they did not have general collapse, i.e. they did not experience progressive collapse. One example is the Banker's Trust Building**
- **Nonetheless, the events at the WTC will always be linked to the issue of progressive collapse as it rejuvenated the attempts to address the issue of progressive collapse prevention**

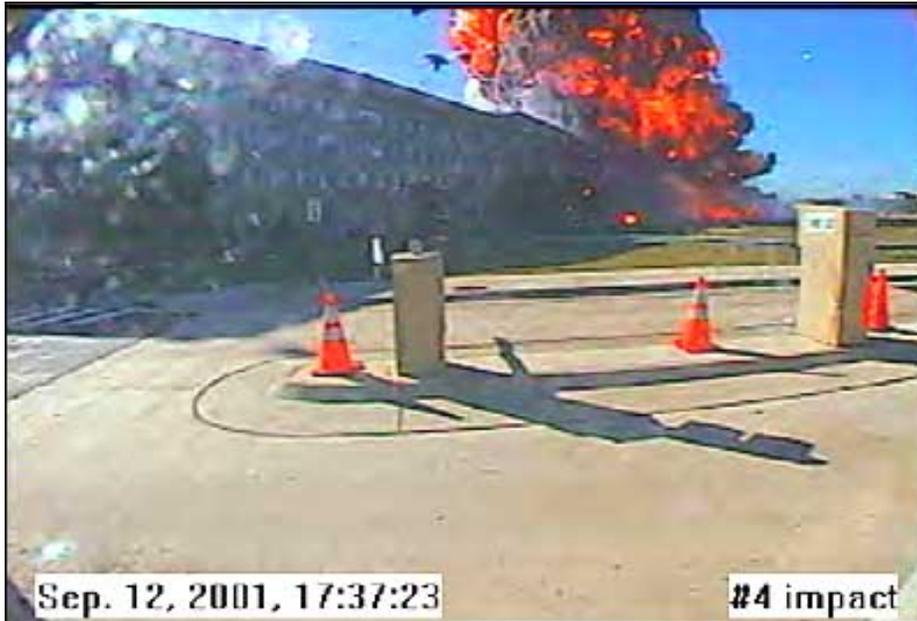
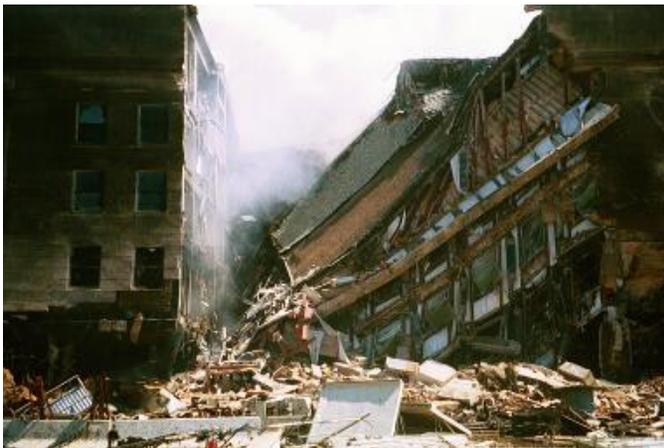
Pentagon, September 11, 2001

- An aircraft was crashed into the Pentagon on 9/11/01
- As was the case in the WTC, the structural system as a whole showed great ability to redistribute load with only a small area of local collapse
- A Building Performance Assessment Team (BPAT) studied the damage for lessons learned from the performance of the structure

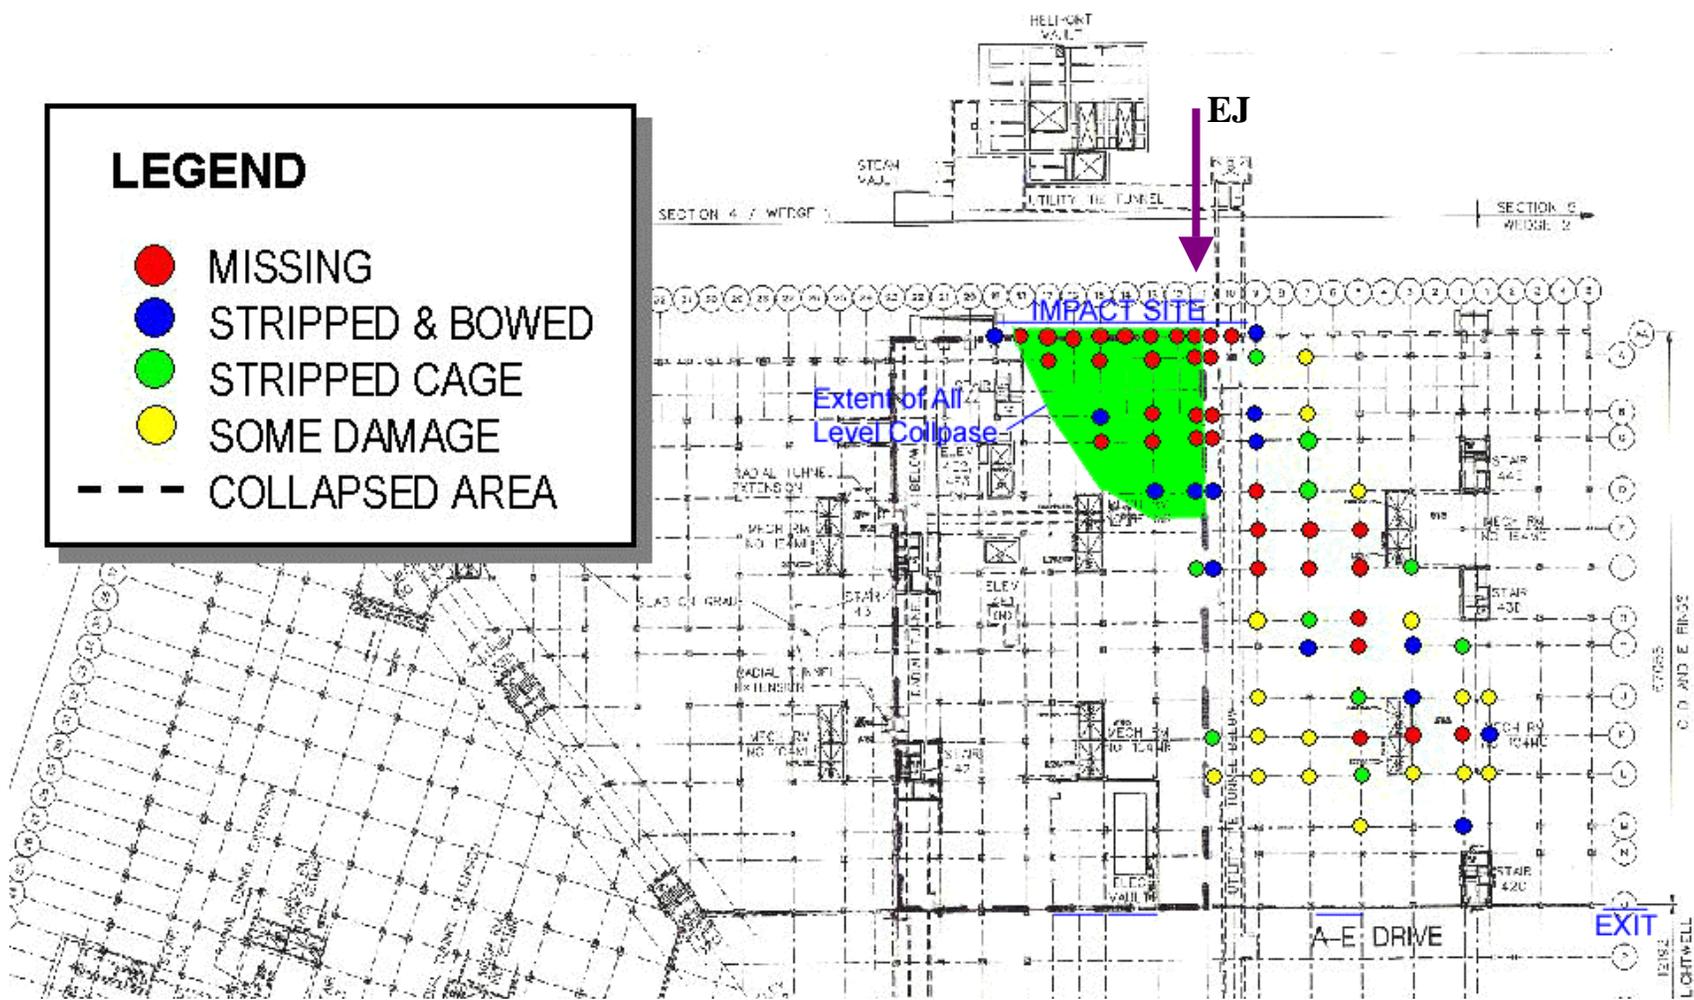
Pentagon, September 11, 2001

- **Findings : collapse limited by following factors**
 - Redundant and alternative load paths of the beam and girder framing system
 - Short spans between columns
 - Substantial continuity of beam and girder bottom reinforcement through supports
 - Design for 150 psf warehouse live load in excess of service load
 - Significant residual load capacity of damaged spirally reinforced columns
 - Ability of exterior walls to act as transfer girders

- **Recommendations for Design and Construction – features validated to reduce collapse from severely abnormal loads:**
 - Continuity, as in the extension of bottom beam reinforcement through the columns
 - Redundancy, as in the two-way beam and girder system
 - Energy-absorbing capacity, as in the spirally reinforced columns
 - Reserve strength, as provided by the original design for live load in excess of service
- **Report noted need for effort to accumulate research and practical experience in area of structural robustness so an authoritative guide can be prepared for the design community**

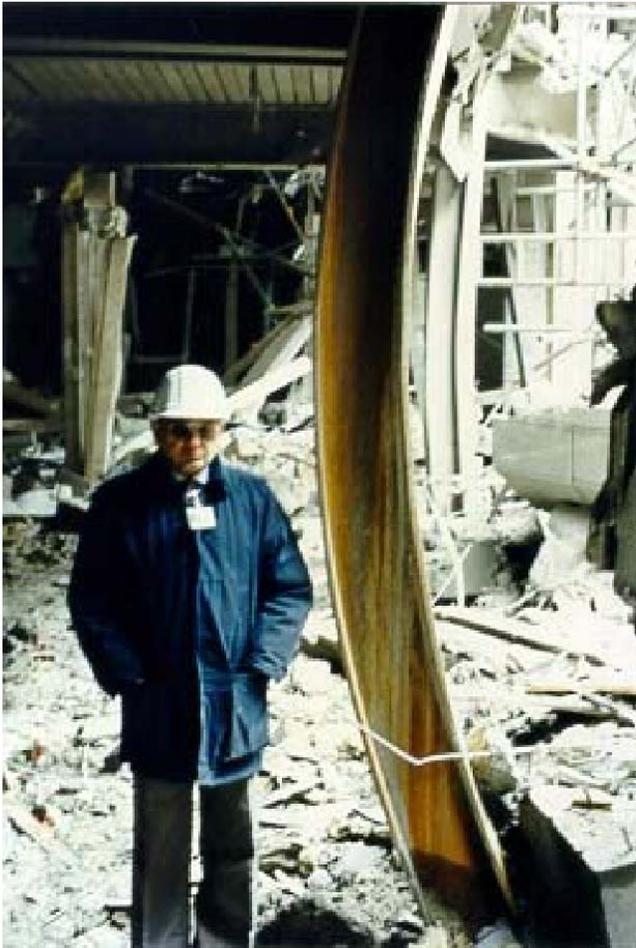
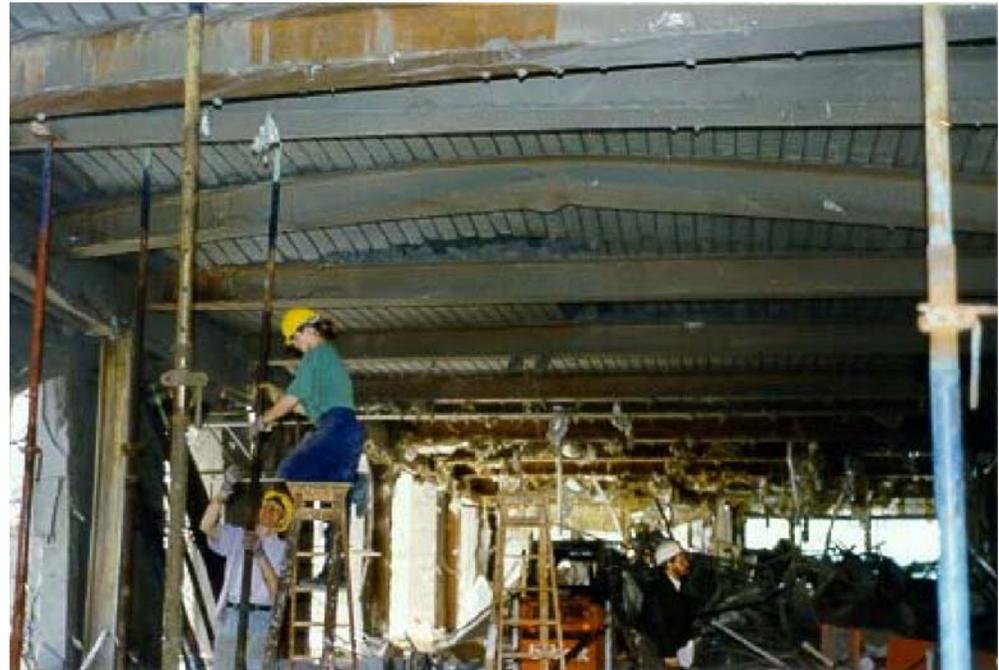
Exchequer Court

- **Semtex bomb explosion 6 meters from building**
- **Exchequer Court was a “modern” steel frame building with in-situ concrete floors**
- **Braced frame construction, so all connections were designed for shear only, except design had to provide tying forces in accordance with British standards**
- **Connections were flush-end plate type, shear connections**
- **Building was significantly damaged but did not suffer collapse**

- Column Displacements were found of 125mm and 406mm for two of the first floor columns
- Some of the edge beam to column connections failed in shear

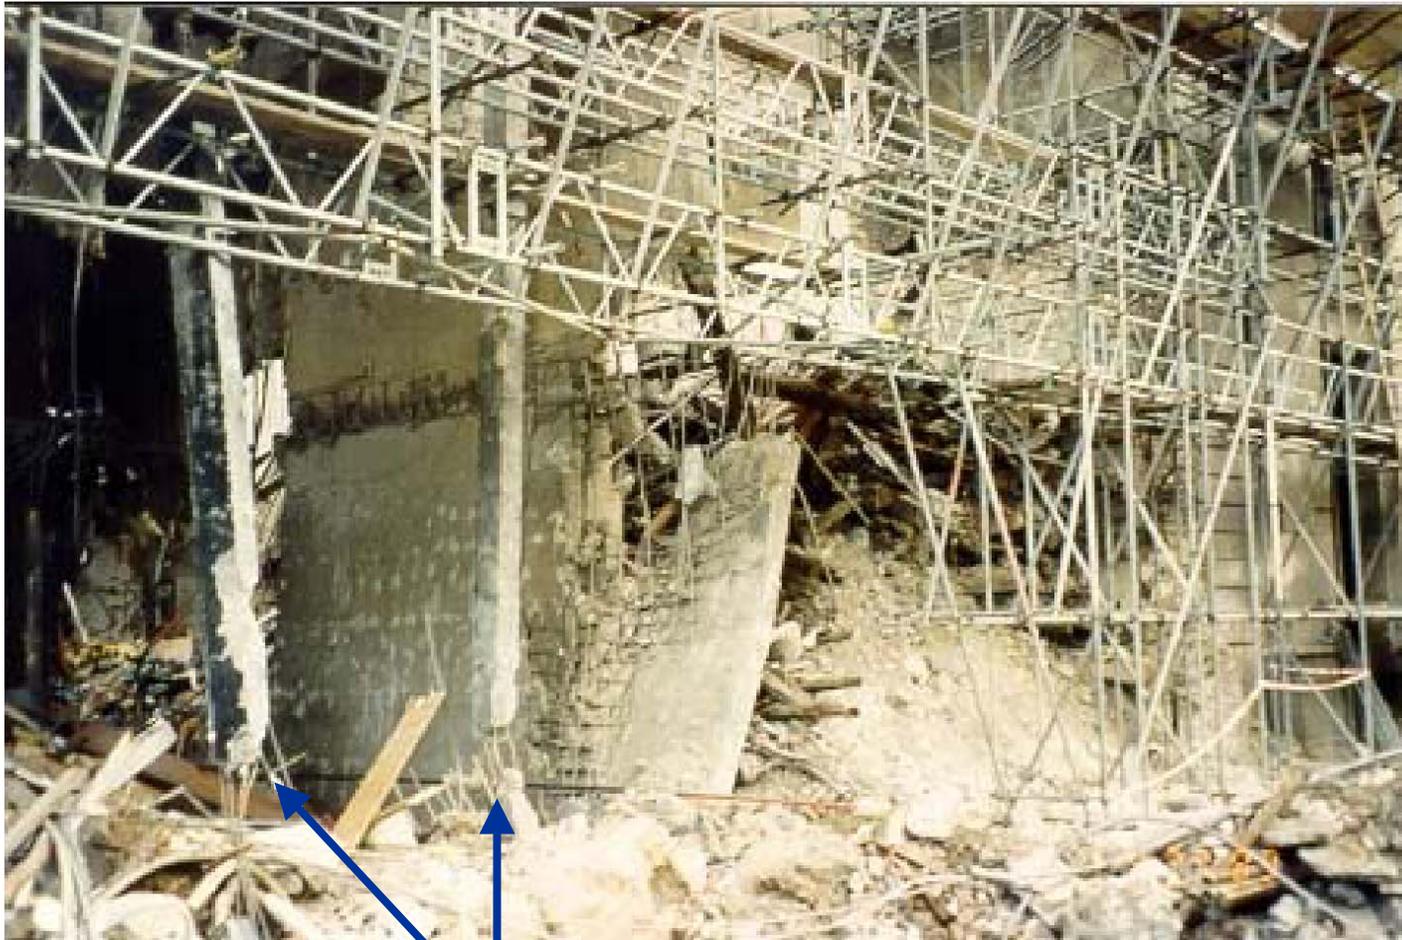
Kansallis House

- **Bomb exploded within 6 meters of building (one report indicated approx. 1000 lb. fertilizer)**
- **Three load bearing columns and 127m² of the 1st floor and 73m² of the 2nd and 3rd floors immediately above these columns were lost. In spite of this damage the majority of the building remained intact.**

- **The mechanism that enabled the remaining part of the building to bridge over the missing columns is unknown but clearly the design provisions provided sufficient redundancy in the structure to allow such bridging to occur.**

Column Failure
